EAST LAKE RESERVOIR DAM

CT. 00066

PHASE I INSPECTION REPORT
NATIONAL DAM INSPECTION PROGRAM

JANUARY 1979

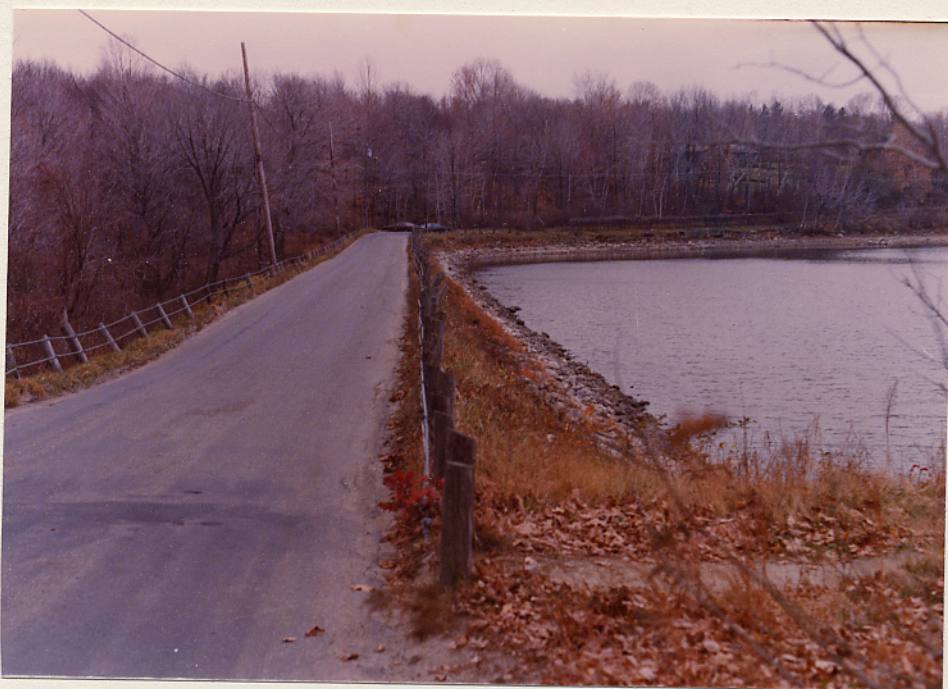
Overview from left abutment

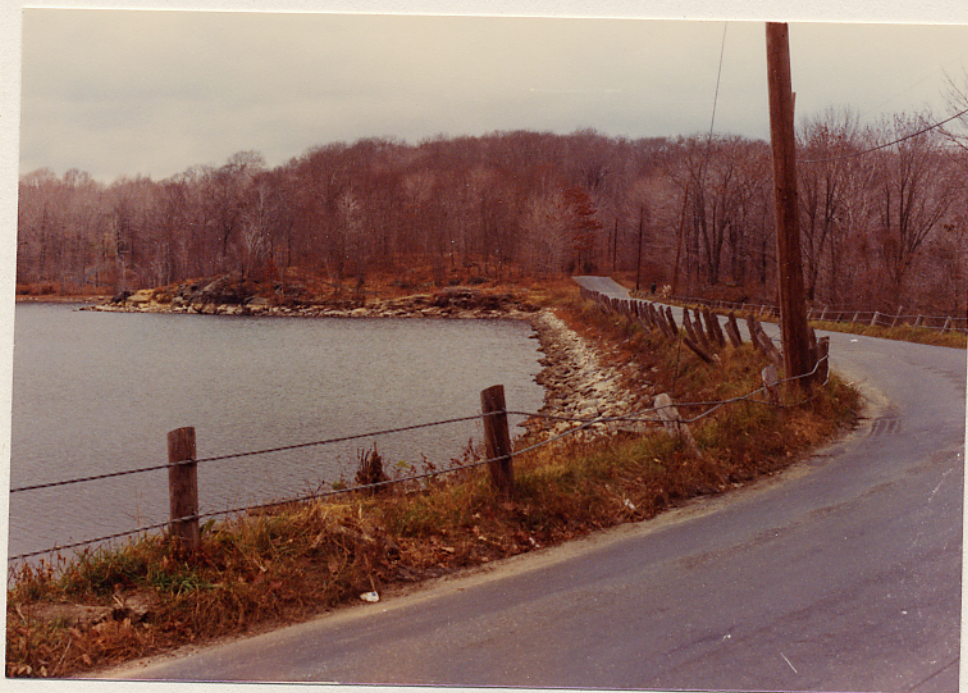
Overview from right abutment

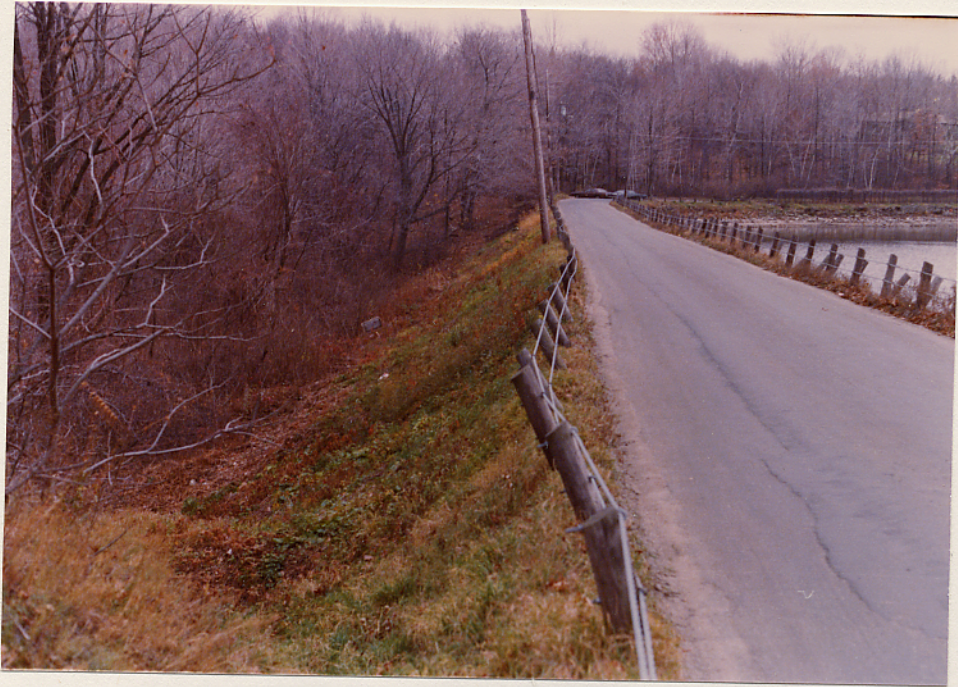
The downstream slope of the dam is also very steep at the top and it would seem that the highway has been raised and widened without a corresponding fattening of this slope. Within the west third of the dam, for example, longitudinal cracks are evident in the surface of the road indicative of sloughing. There is also as much as 2-3 ft. differential between gutter and crown on the downstream side. The tilting of the guard rail posts associated with slope sliding is illustrated in Photo No. 1 (Appendix C).

1. Downstream slope from left abutment

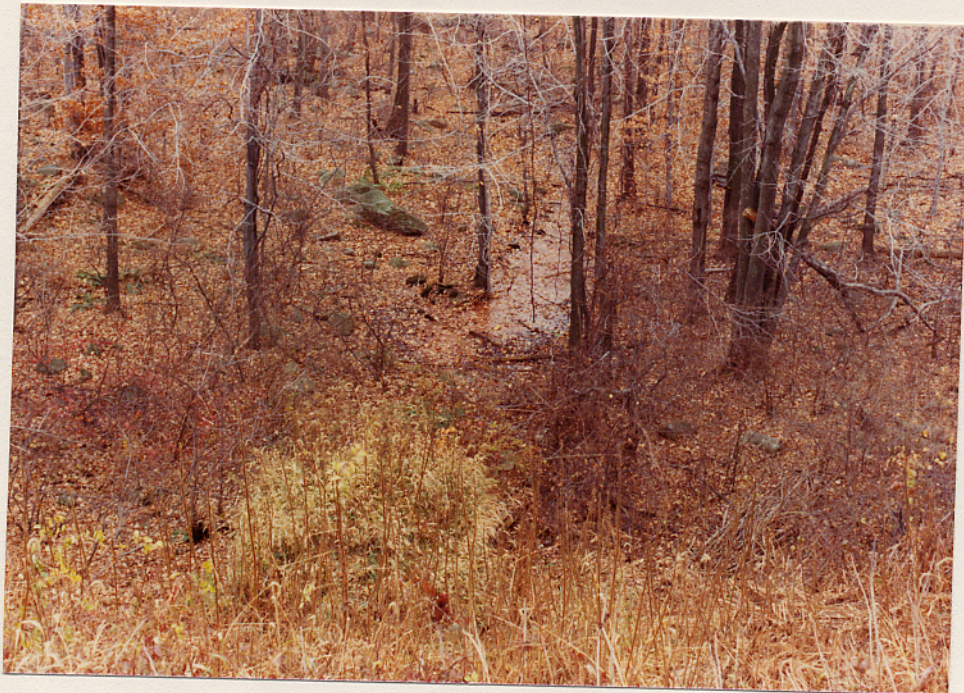
2. Main outlet channel from top of dam

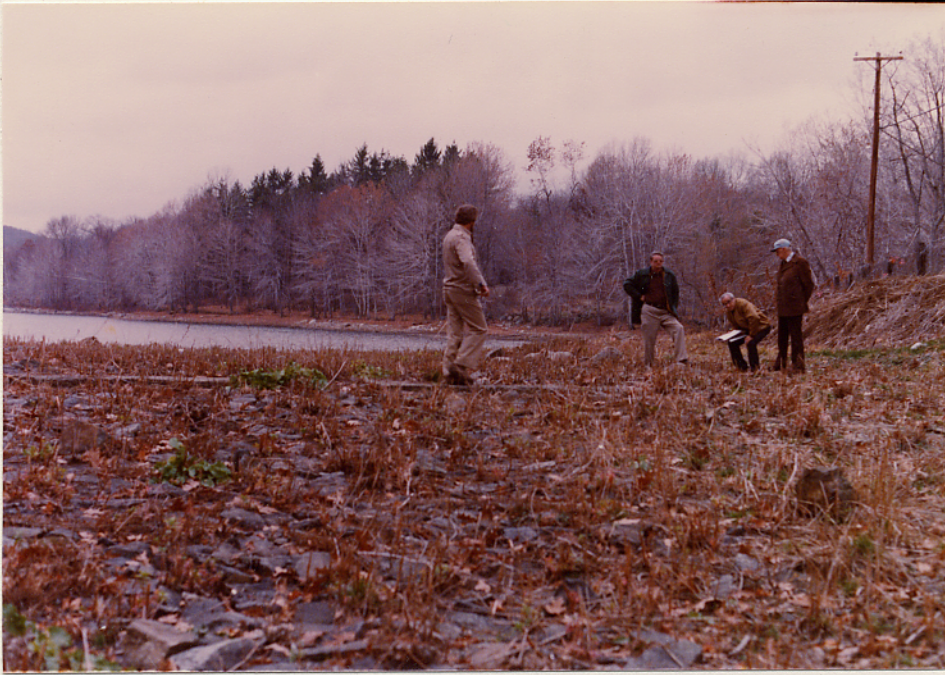
3. Spillway sill and discharge channel, looking towards reservoir

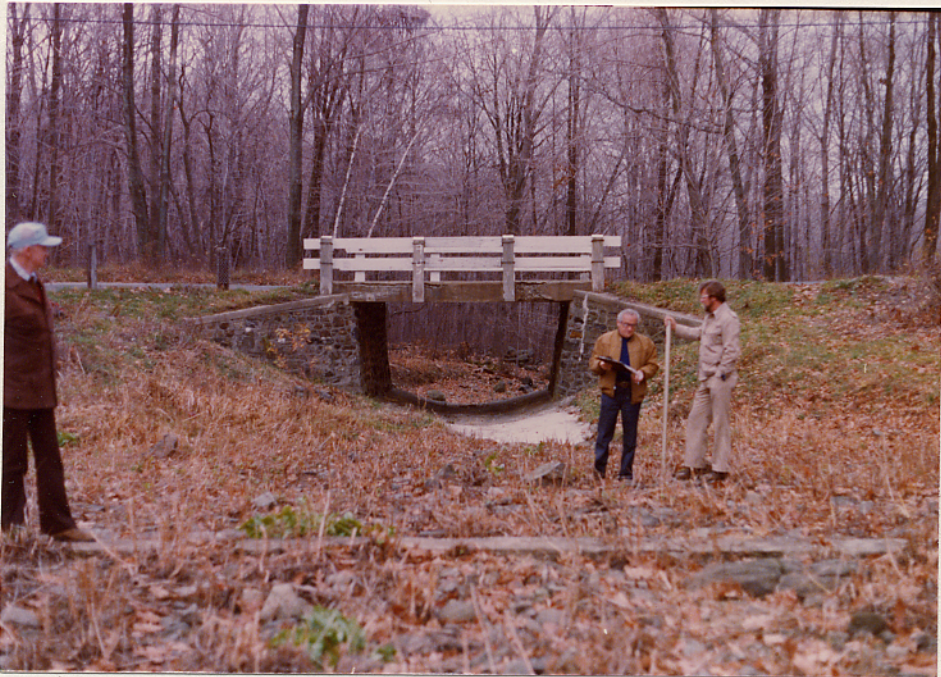
4. Spillway sill and discharge channel looking downstream, showing bridge

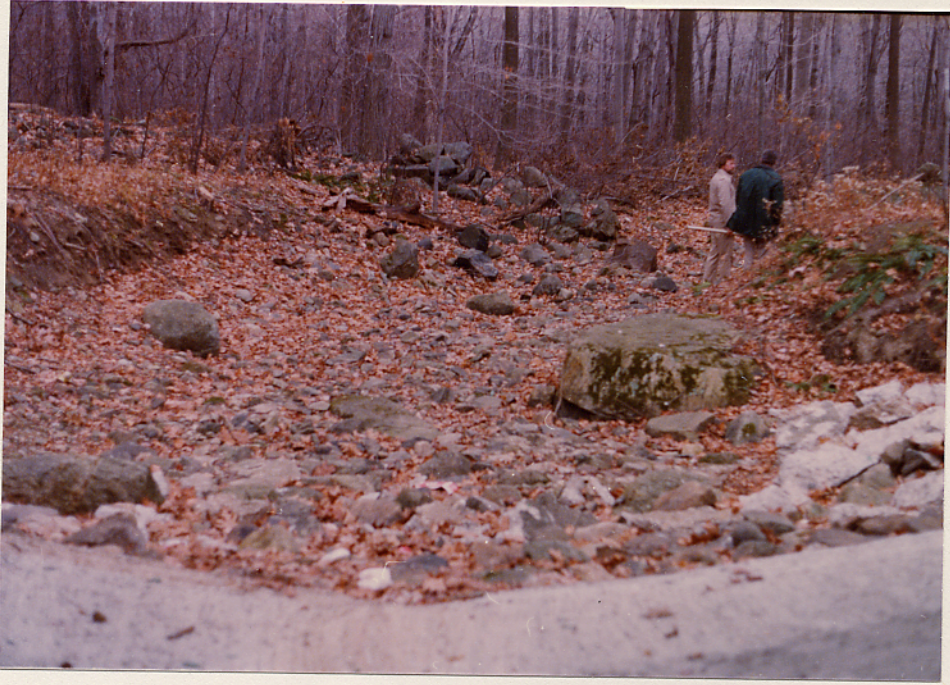
5. Spillway discharge channel looking downstream from bridge crossing

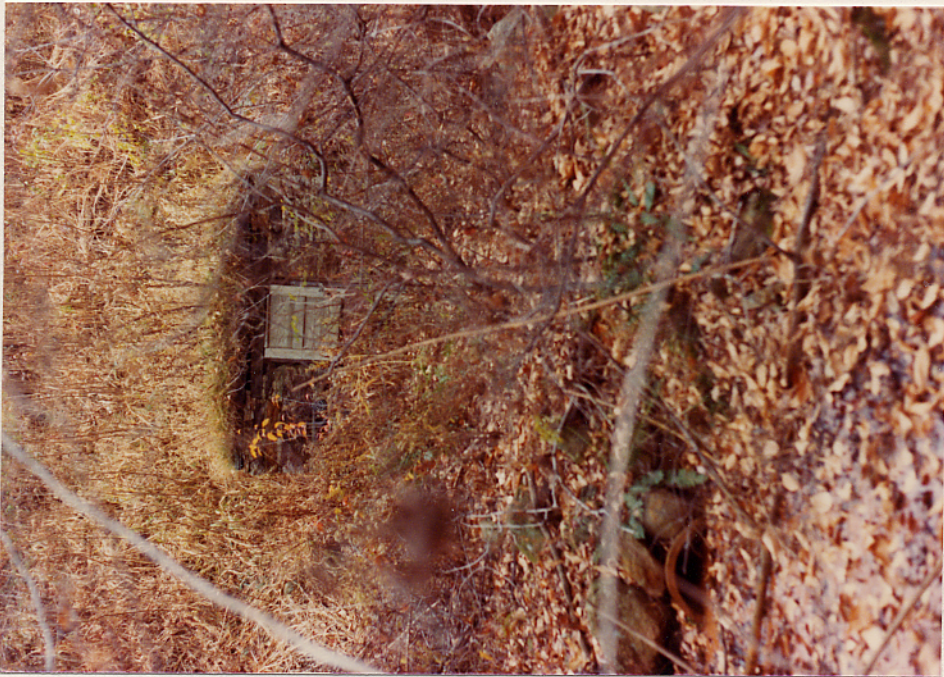
16 in. dia. blowoff valve, condition doubtful.

6. 16 in. dia. blowoff pipe and valve house for 12 in. dia. outlet pipe to Margerie Lake
